## SIA “Growing Pains” – a history of blatant non-compliance!

by Dave Hutchinson for May, 2015 Shawnigan Focus

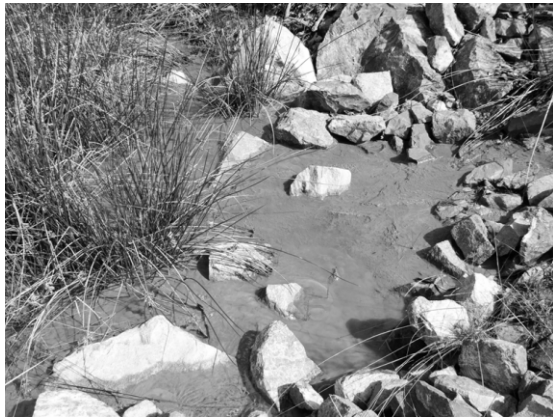
One flank of the Lot 23 stockpile parallels Shawnigan Creek and tapers down to within a few metres of this vital source of Shawnigan Lake water. Oozing from this is a repugnant red leachate which gathers in puddles covered with an oily sheen, and then flows into the creek. This has been happening for years! Recent analysis by Dr. Andrew Weaver, Green Party MLA, has confirmed earlier findings that there are serious contaminants. MoE, still steadfastly defending their Waste Permit decision, have agreed to perform follow-up testing of the water and the site itself. It is crucial that these tests are comprehensive and verifiable.

Red ooze from Lot 21 leaching into Shawnigan Creek

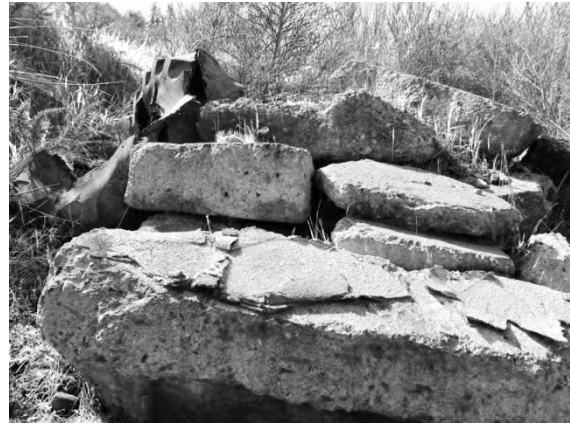
Further along, as you pass the divide between Lots 23 and 21, you come across fill that has been pushed onto CVRD land. The amount increases as you proceed until, midway along Lot 21, the intrusion onto CVRD parkland is truly astonishing – a veritable peninsula, many metres deep and dozens of metres wide. Far from being clean material, it is substantially riddled with concrete, metal, plastic, asphalt, tires and wood-waste, all in contravention of the Mine Permit. This is all observable in the fill pushed onto the CVRD parkland. Who knows what exists 50 metres beneath the surface of the SIA property.

SIA waste on CVRD parkland

*The sloughing or material that encroached on to the CVRD property can be removed ... the property impacted by the encroachment must be cleaned up and returned to its pre-encroachment state, to the satisfaction of the property owner.*
